*Geomorphic and Riparian
Vegetation Assessment
of the
Proposed Napa River Flood Control Project
near the
City of St. Helena, Napa County, California*

Mitchell Swanson, Swanson Hydrology & Geomorphology

October 31, 2002

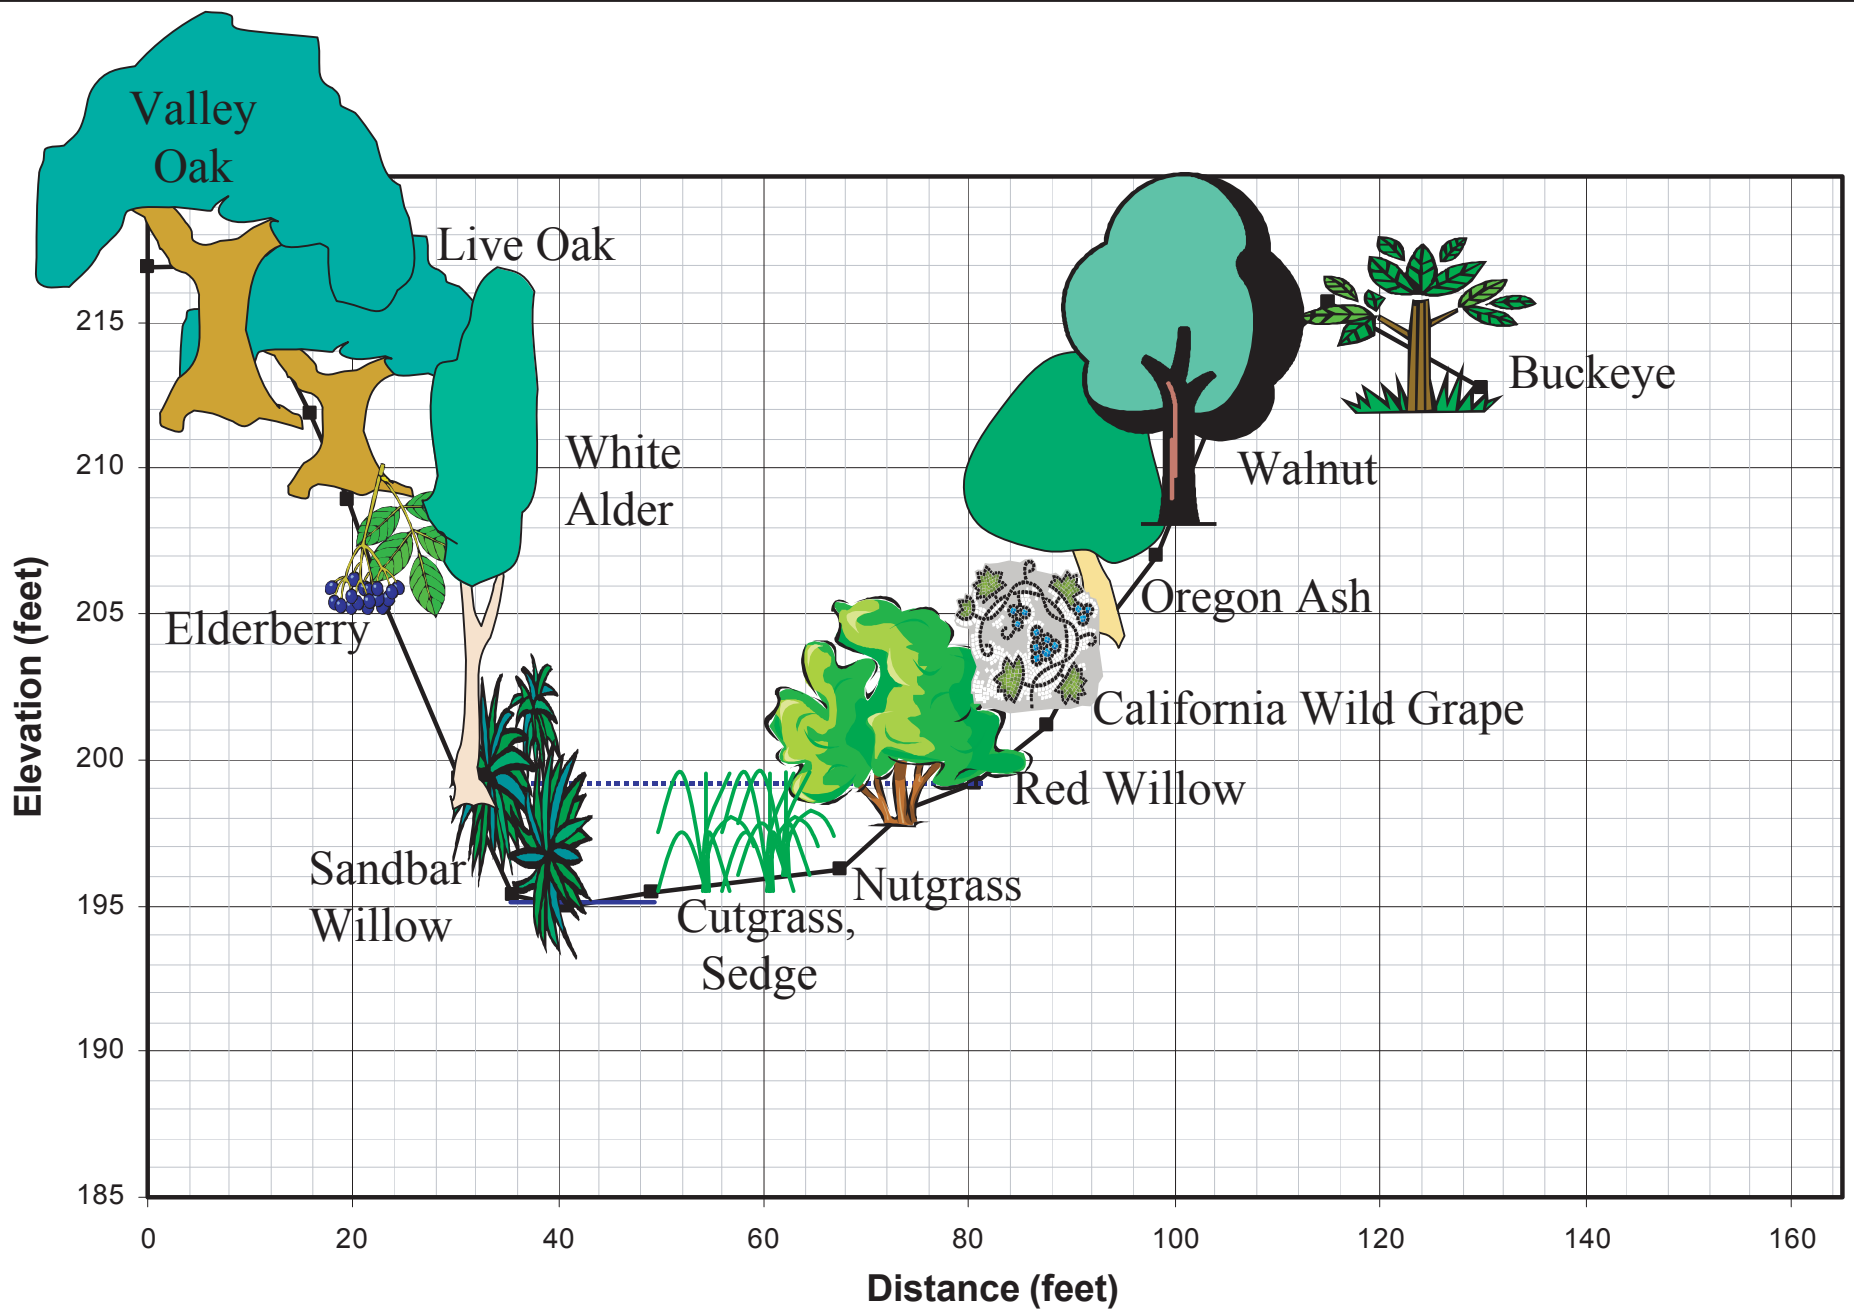
Figure 16: Generalized vegetation relationships along actual SH&G cross section 1.

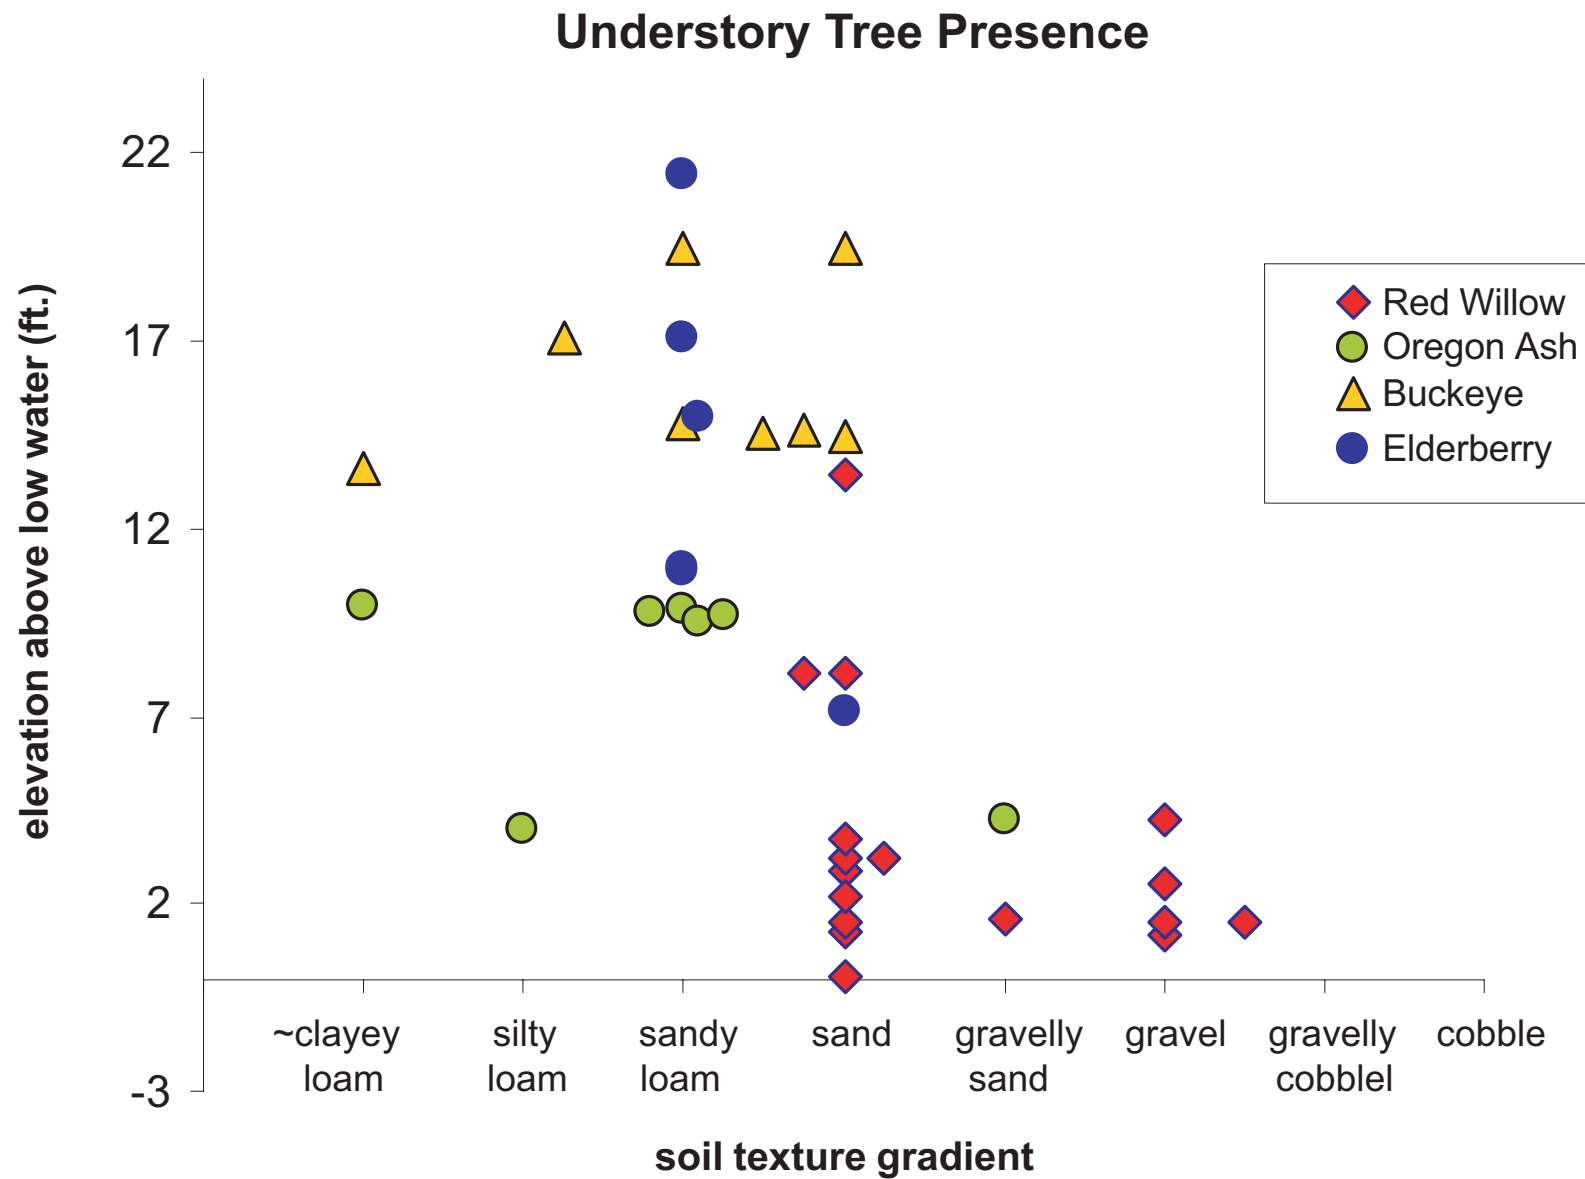
Figure 18: Relation of understory tree occurrence to elevation above summer low flow and soil texture.

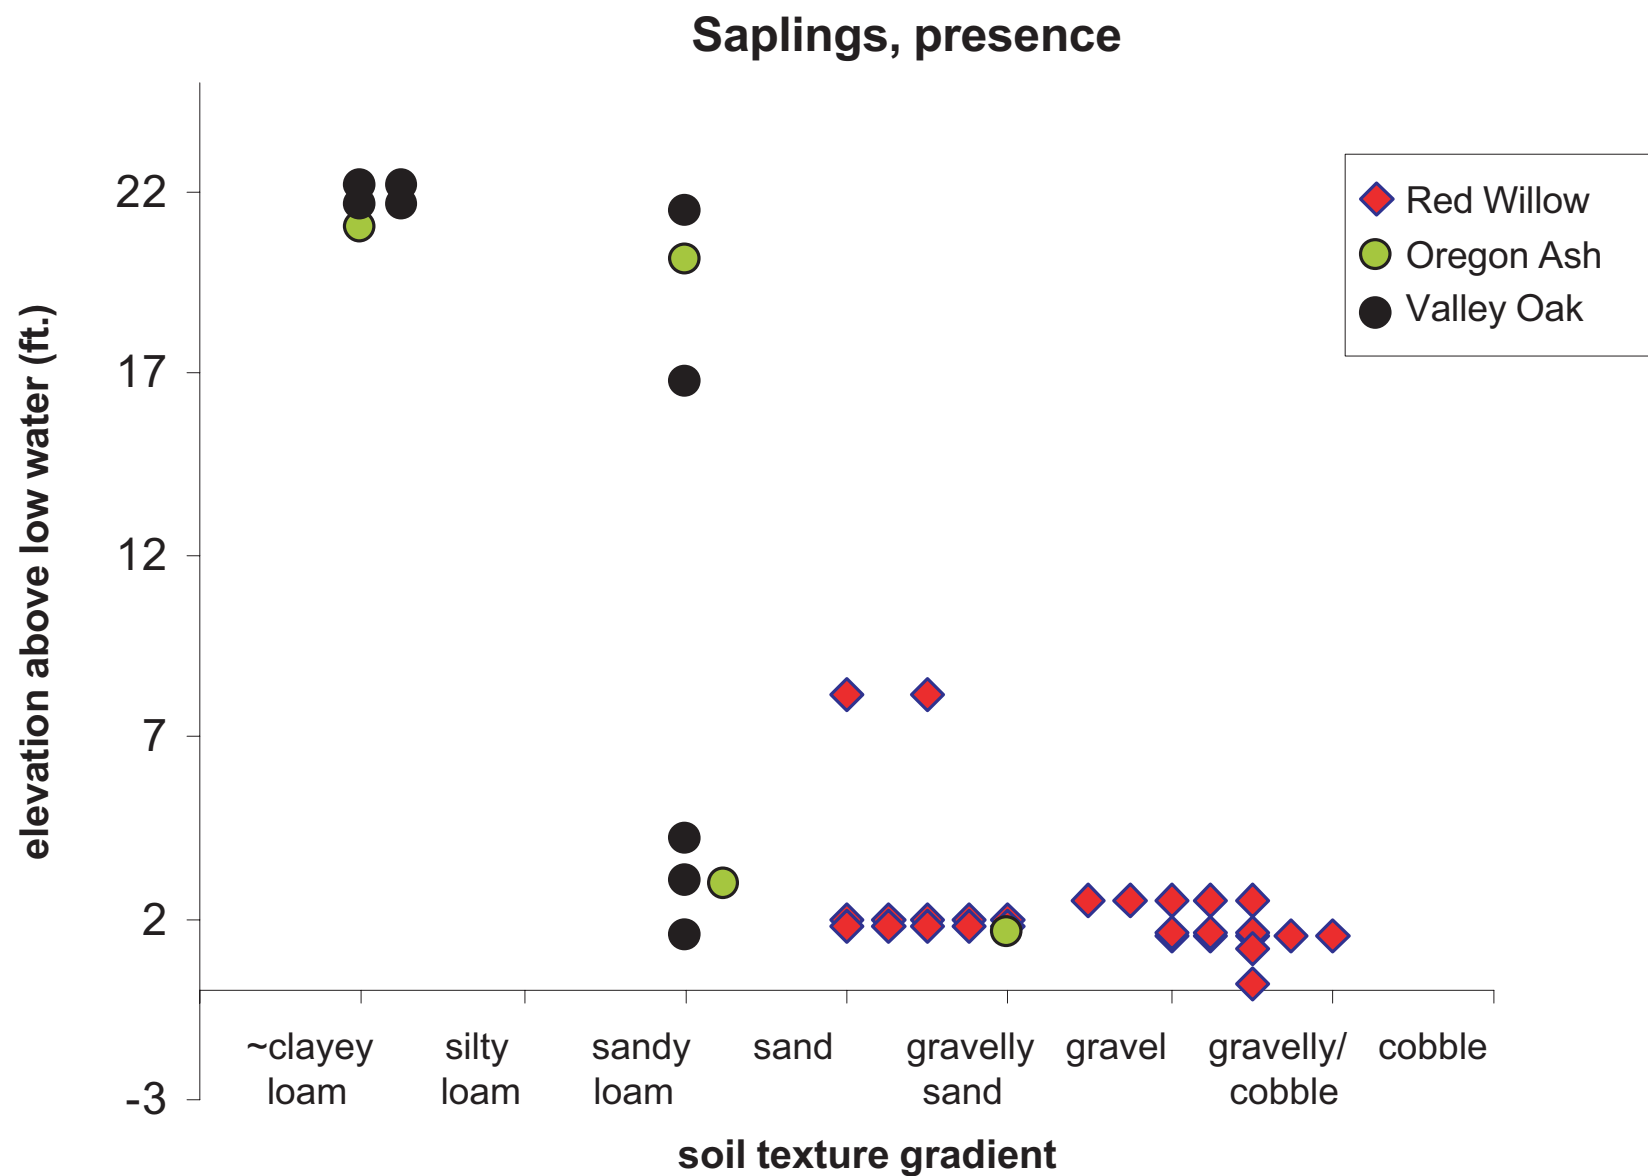
Figure 19: Relation of sapling occurrence to elevation above summer low flow and soil texture.

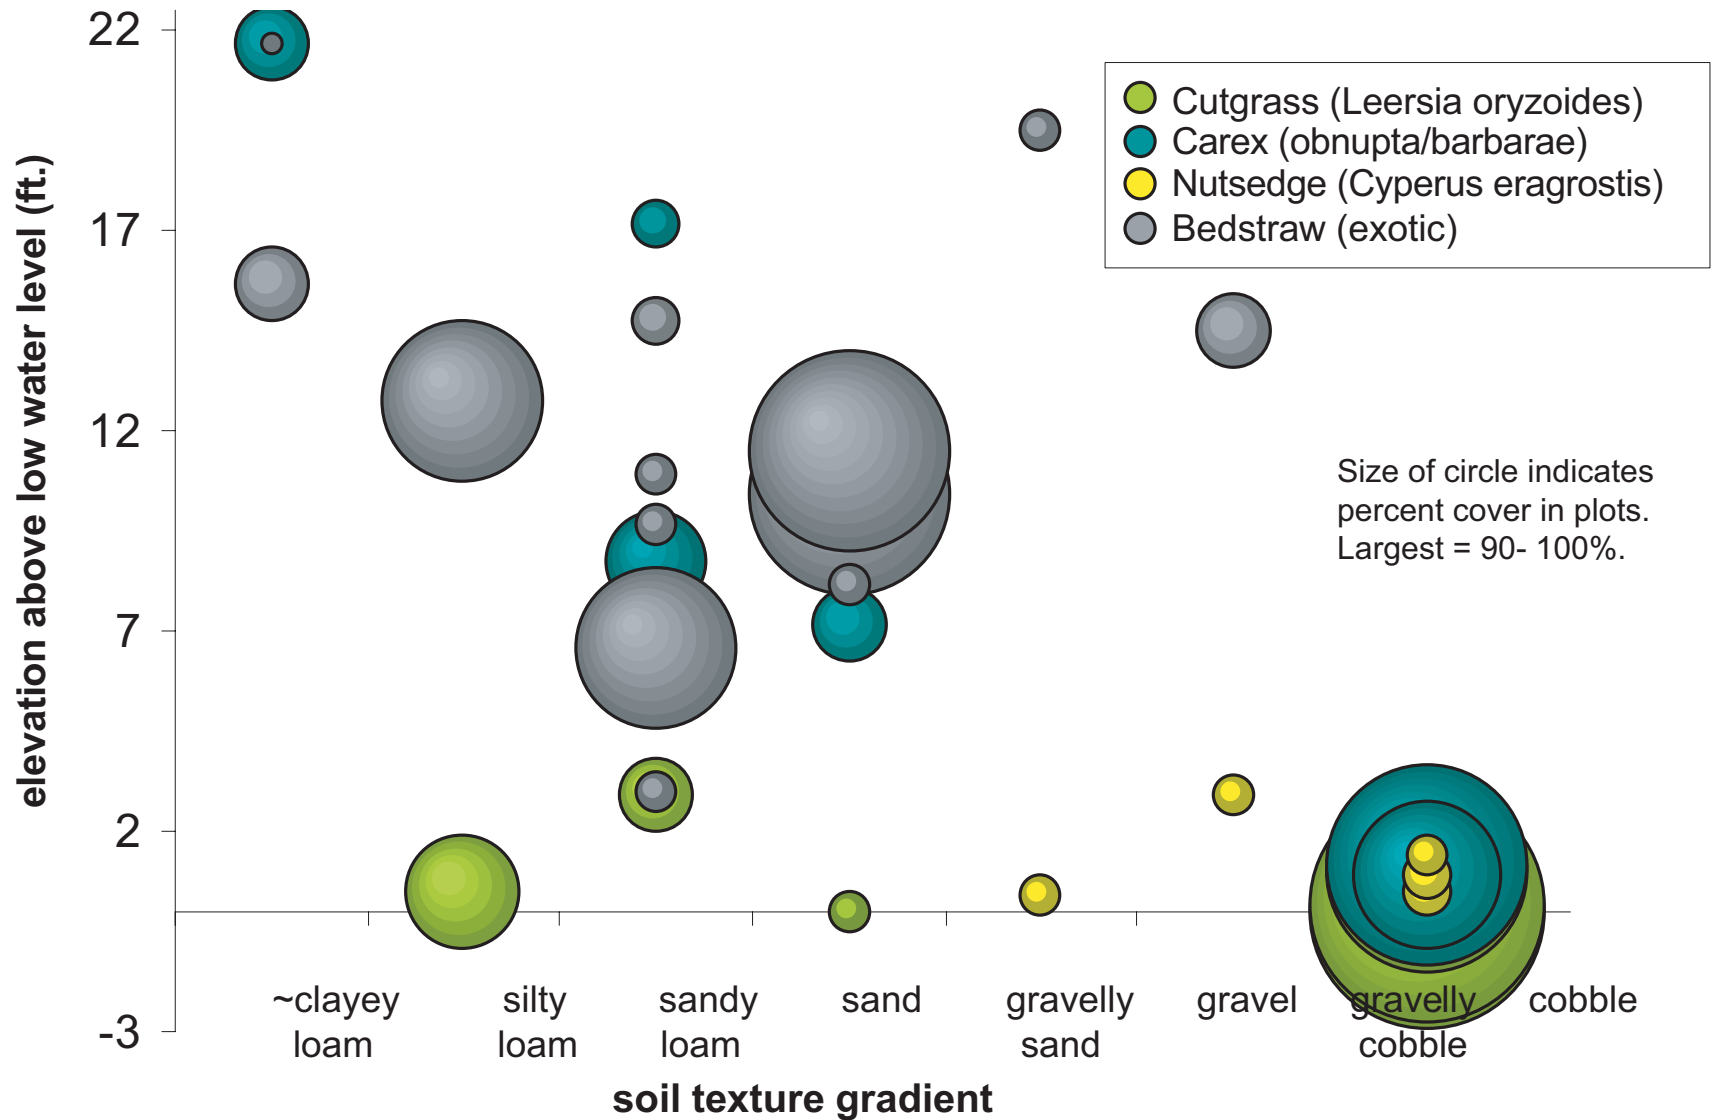
Figure 22: Relation of understory herbaceous vegetation percent cover to summer low flow and soil texture.

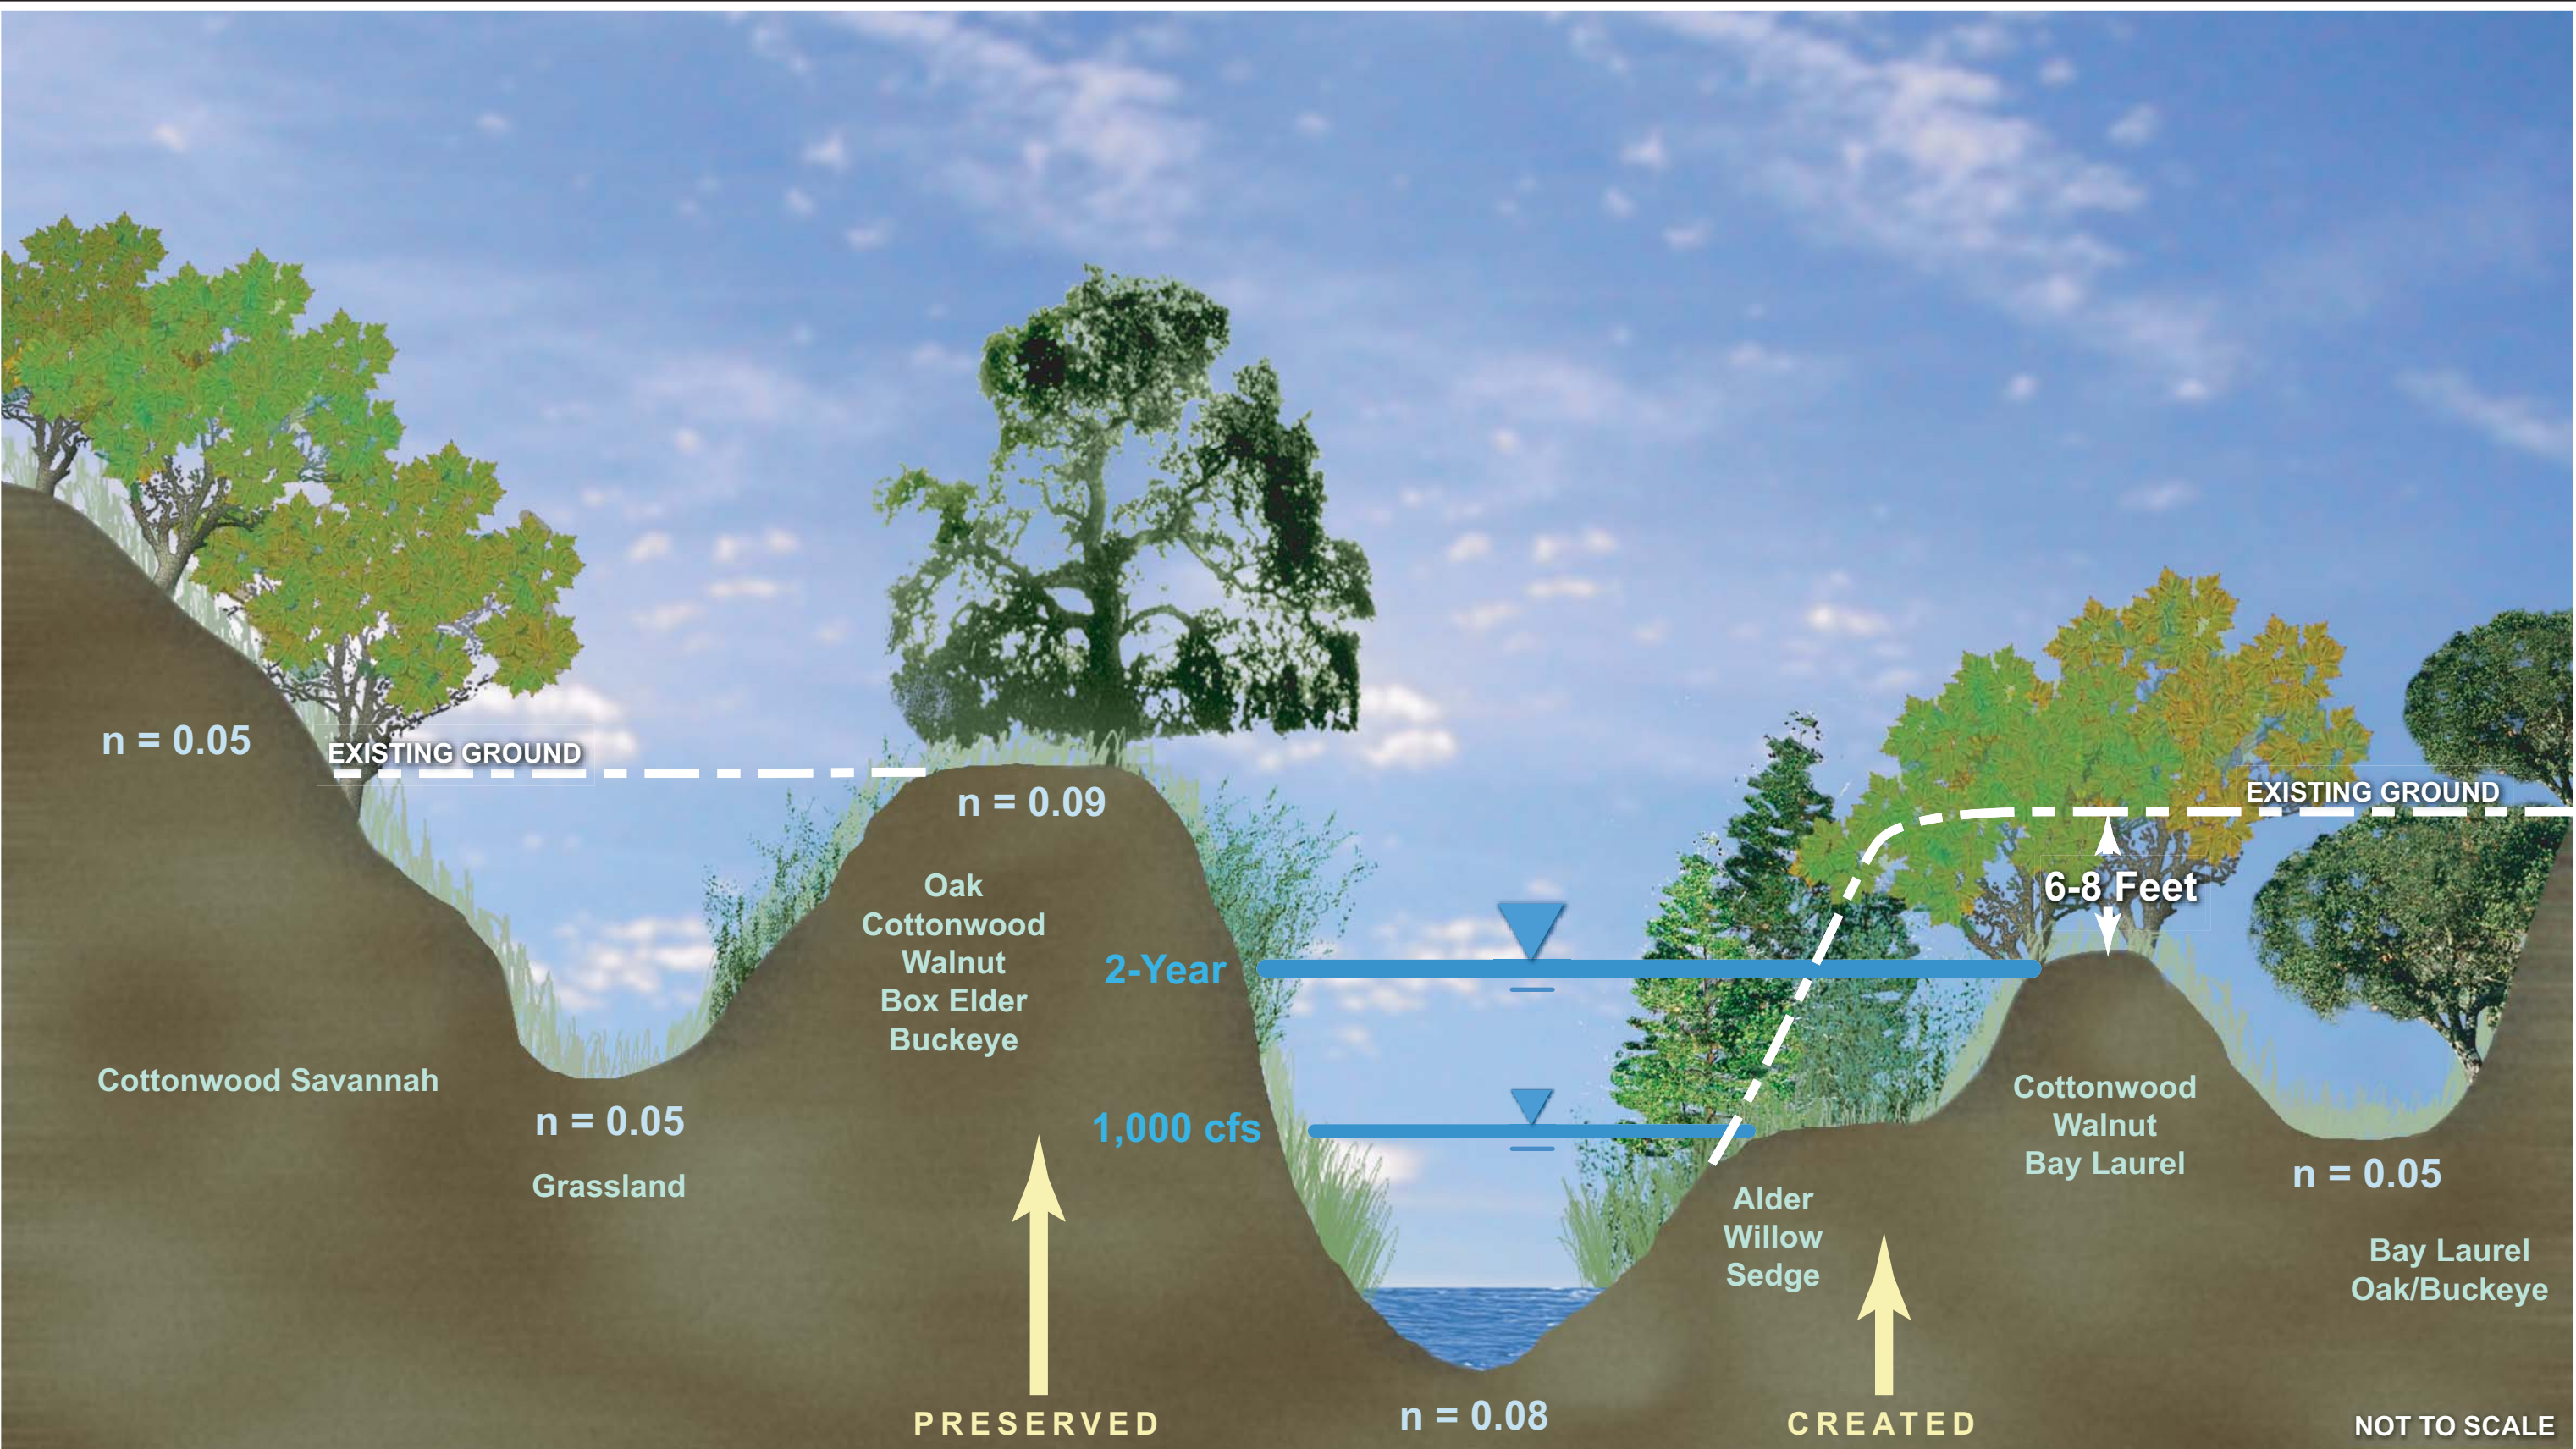
Figure 24: Napa River near St. Helena showing conceptual depiction of post-project topography and potential vegetation communities. Light blue labels below the ground surface indicate target Mannings' hydraulic roughness values. Location of the large valley oak represents mature riparian forest to be preserved along existing banks. Areal extents for terrace areas and riparian preservation are shown in plan view in Figure 3. The south bank is expected to be excavated 6-8 feet for forested areas and more so for channel areas

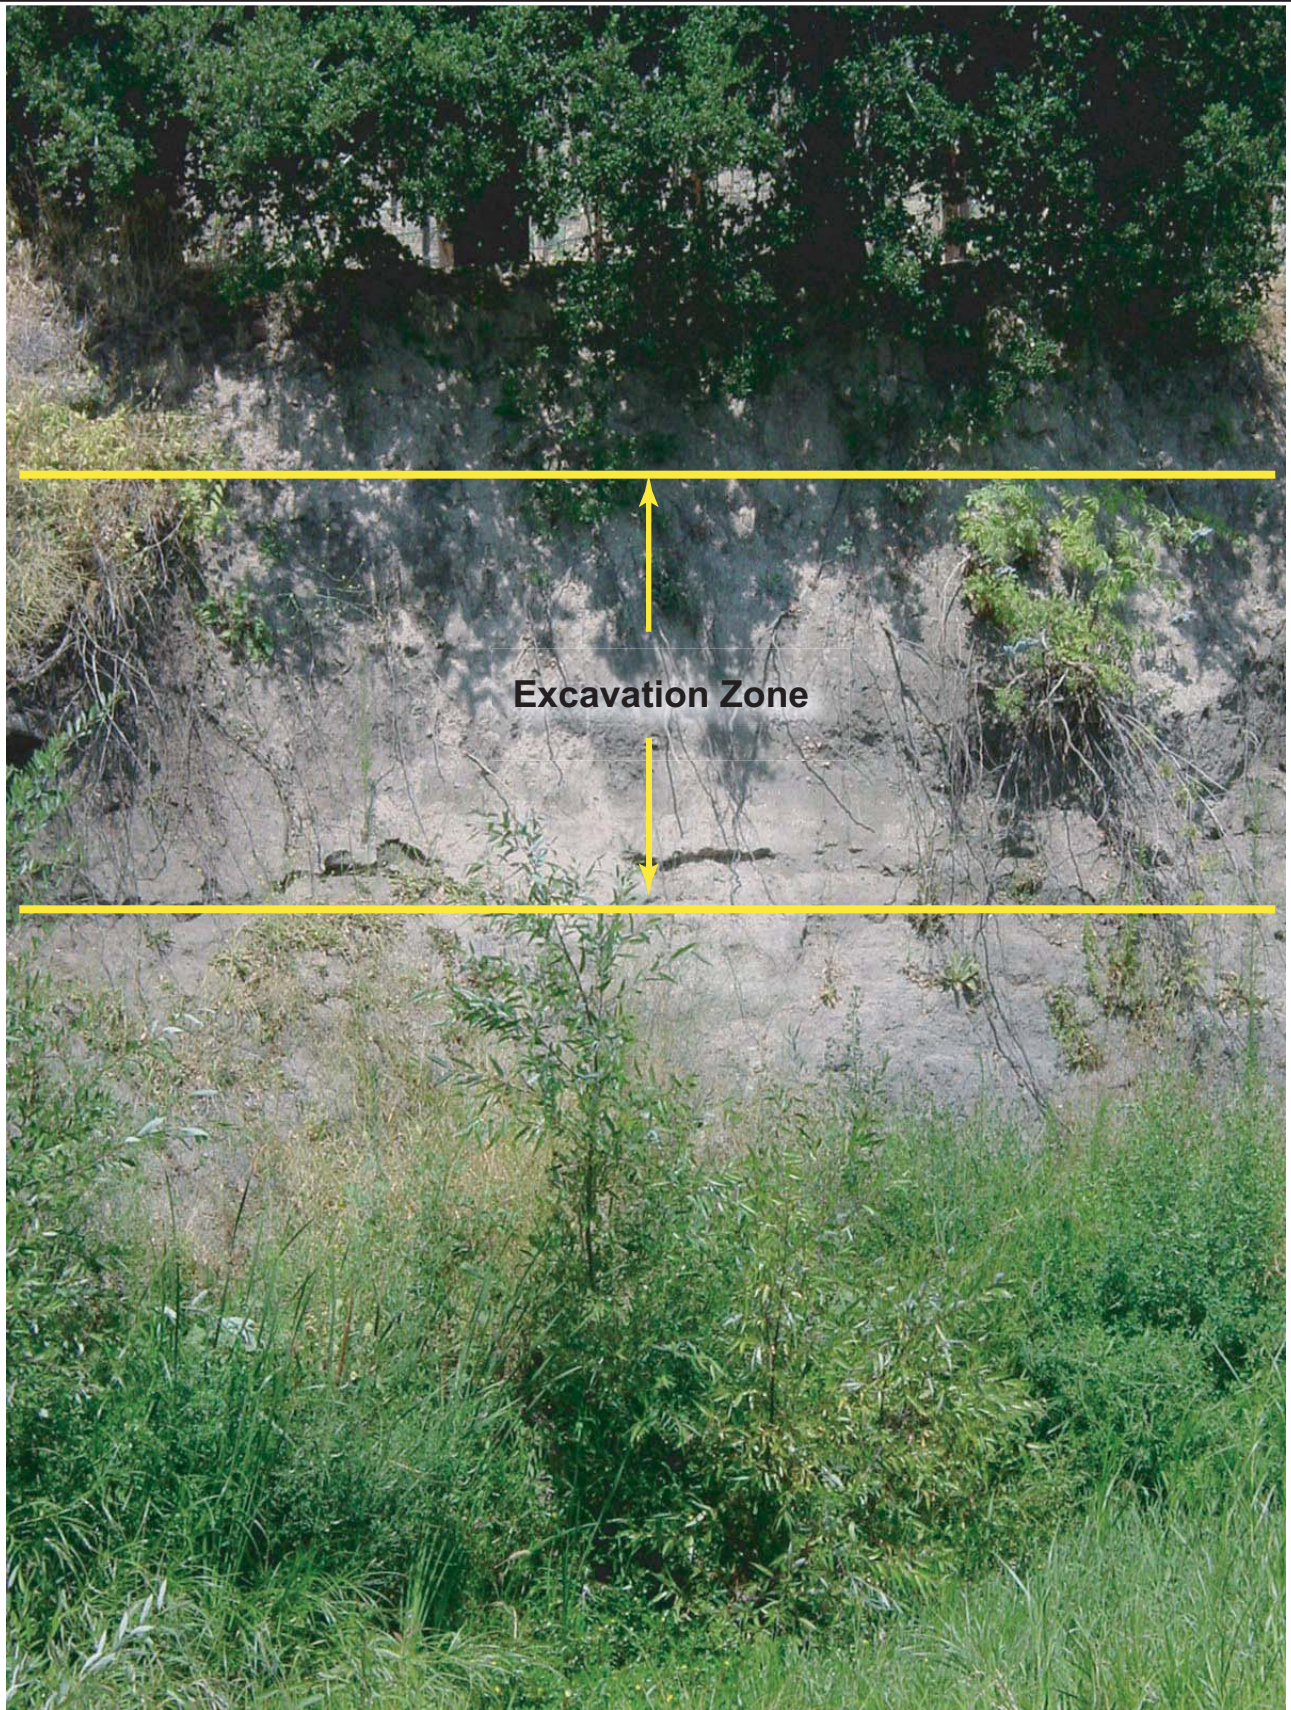
Figure 26: Exposure of soils along the north bank of the Napa River in the project reach opposite the Vineyard Valley Mobile Home Park. The proposed excavation depth will be 6-8 feet on average below the top of bank

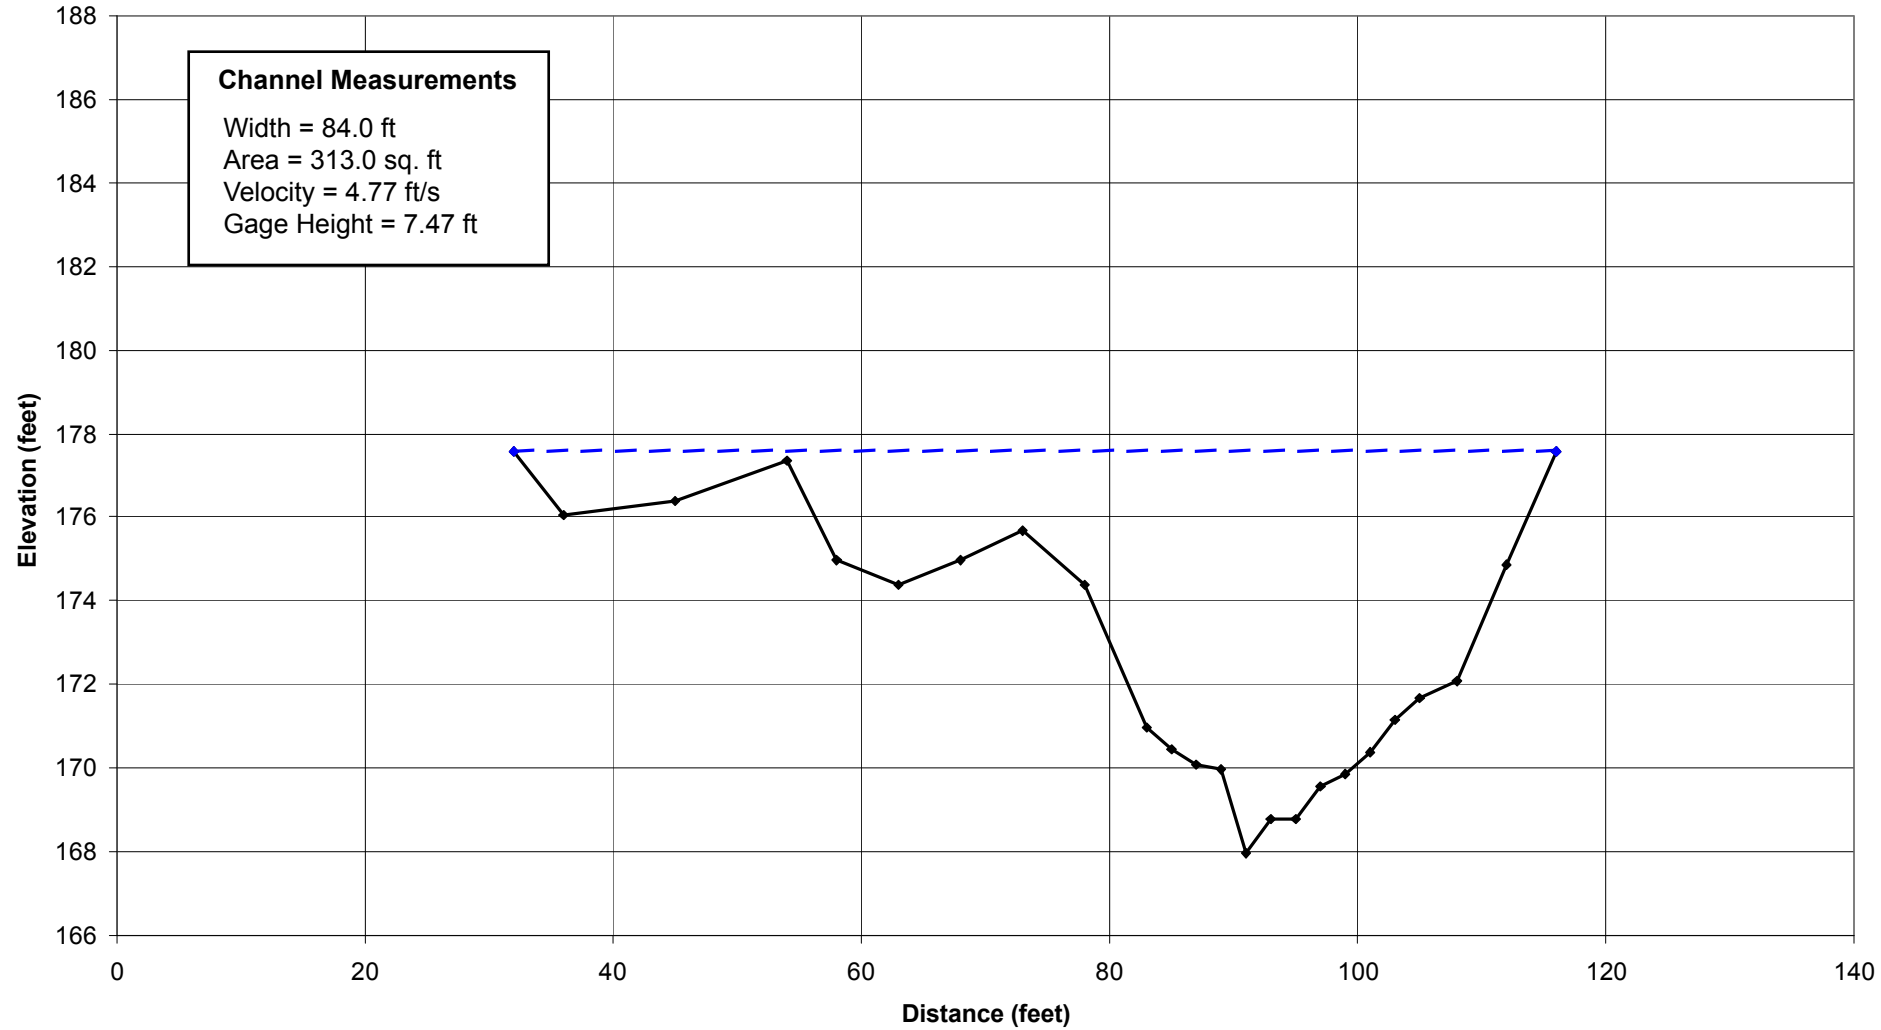
Width = 84.0 ft
Area = 313.0 sq. ft
Velocity = 4.77 ft/s
Gage Height = 7.47 ft
